# Phoebus/Mill Creek Terrace Area Drainage Study

Hampton, Virginia

February 2011

URS Corporation  
11658017

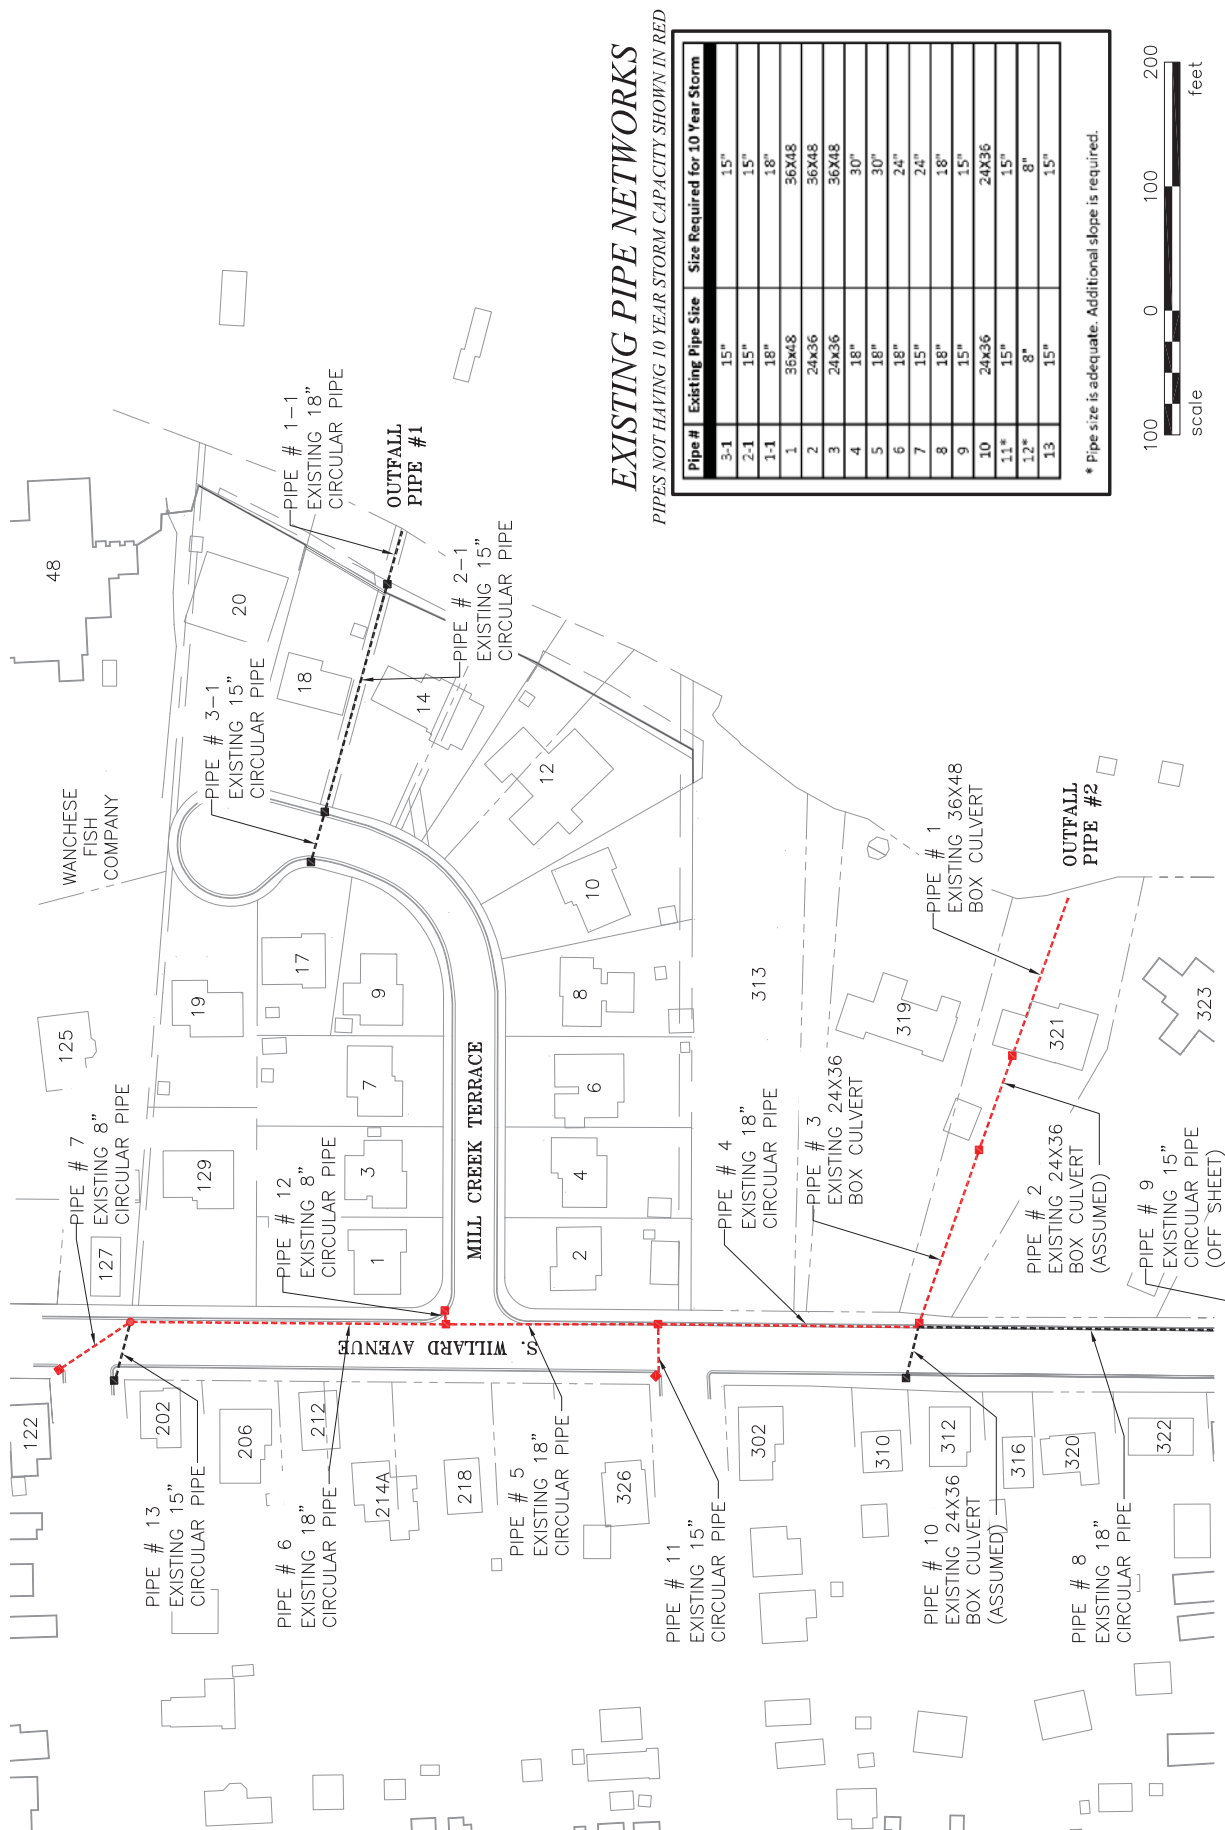
Sheet 12

PIPE #	Existing Pipe Size	Size Required for 10 Year Storm
3-1	15"	15"
2-1	15"	15"
1-1	18"	18"
1	36x48	36x48
2	24x36	36x48
3	24x36	36x48
4	18"	30"
5	18"	30"
6	18"	24"
7	15"	24"
8	18"	18"
9	15"	15"
10	24x36	24x36
11*	15"	15"
12*	8"	8"
13	15"	15"

\* Pipe size is adequate. Additional slope is required.

- 5) Replace undersized storm drain pipeline segments in S. Willard Avenue, as depicted on the mapping in Appendix C. These lines are undersized for a 10-year frequency storm. **A table depicting the estimated pipe sizes needed for a 10-year storm capacity is also included in Appendix C.**

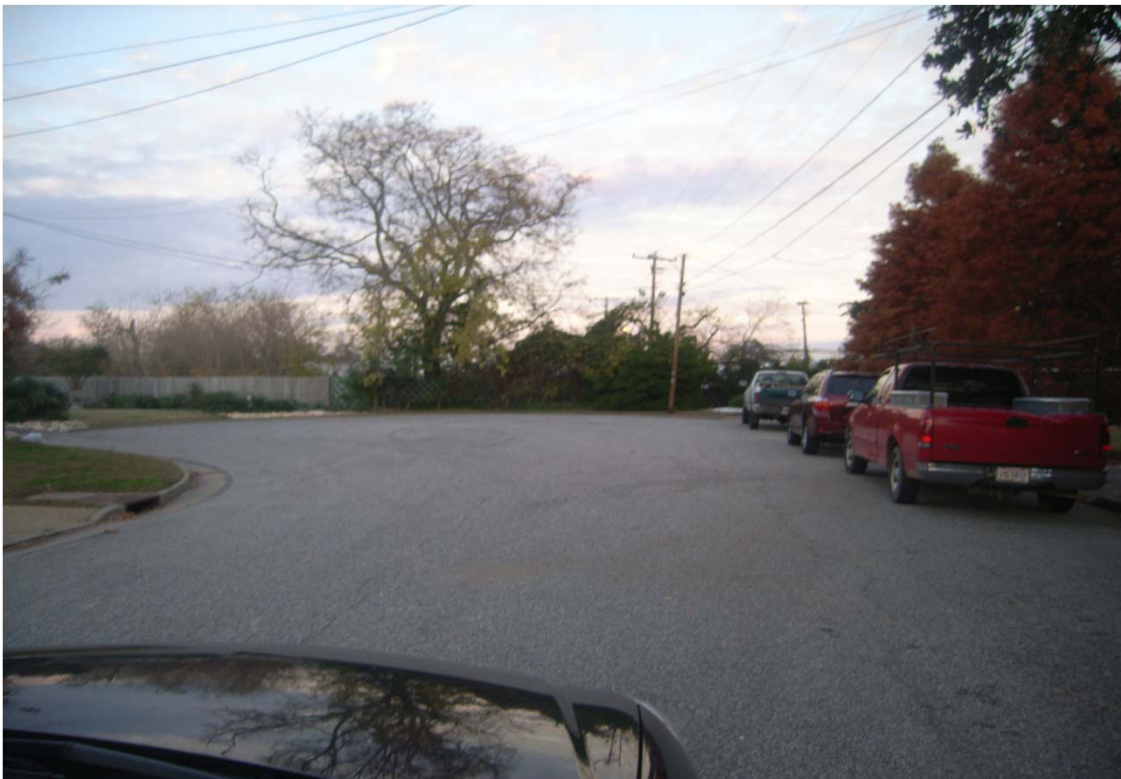
**Looking from 14 Mill Creek Terrace toward Cul-de-sac. Note Curb Drop Inlet on Left**

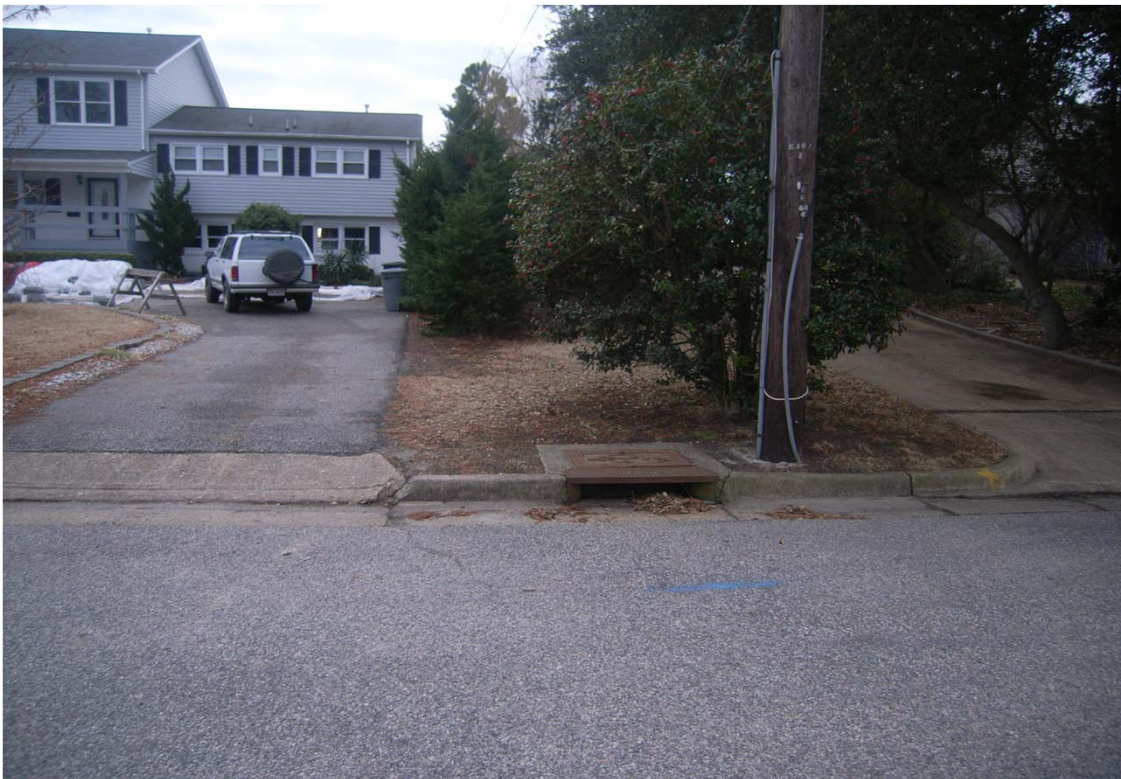
**Mill Creek Terrace Curb Drop Inlet on Outfall #1 between 18 and 14 Mill Creek Terrace**

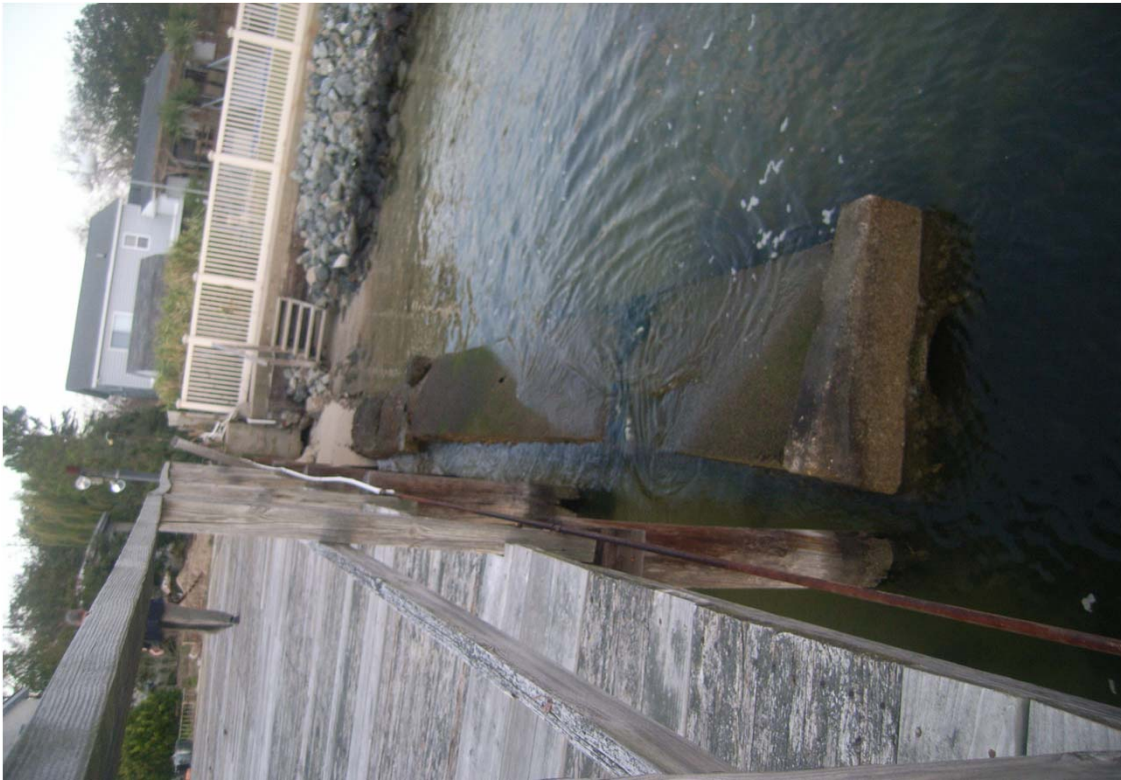
**Outfall #1 Behind 18 Mill Creek Terrace**

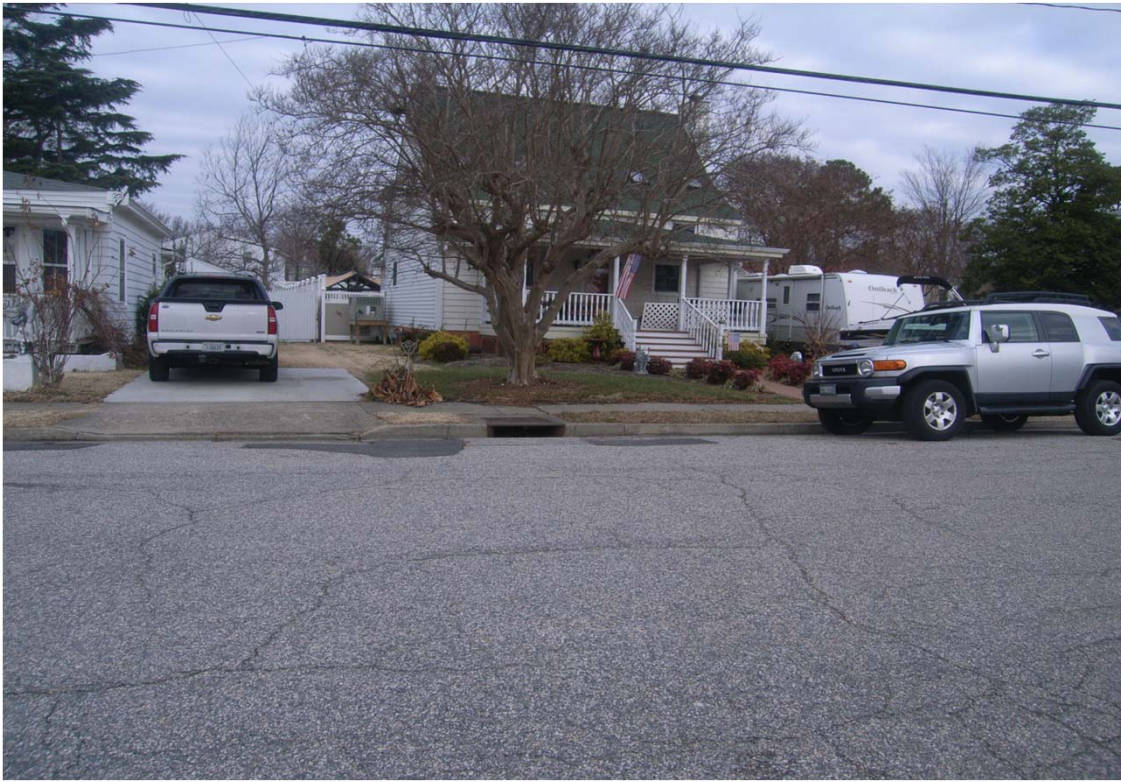
**310 S. Willard Avenue. Note Curb Drop Inlet**

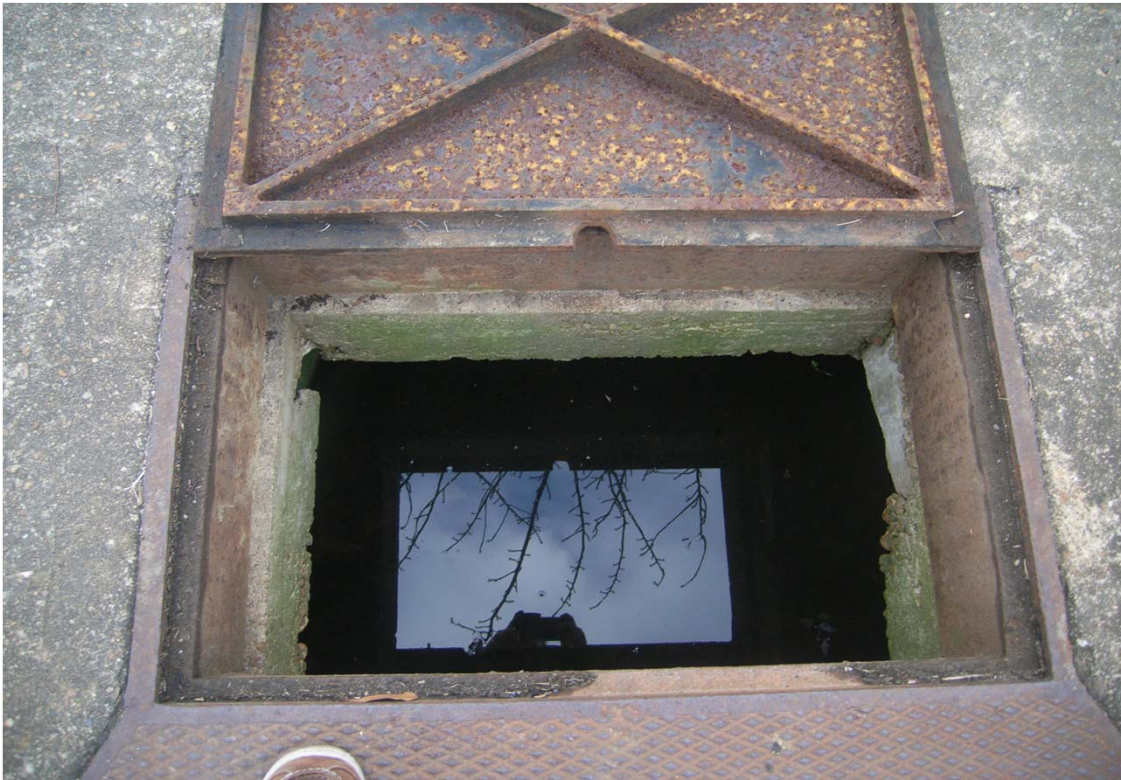
**Outfall #2 Curb Drop Inlet in front of 321 S. Willard Avenue. Note Tidal Water in the Box**

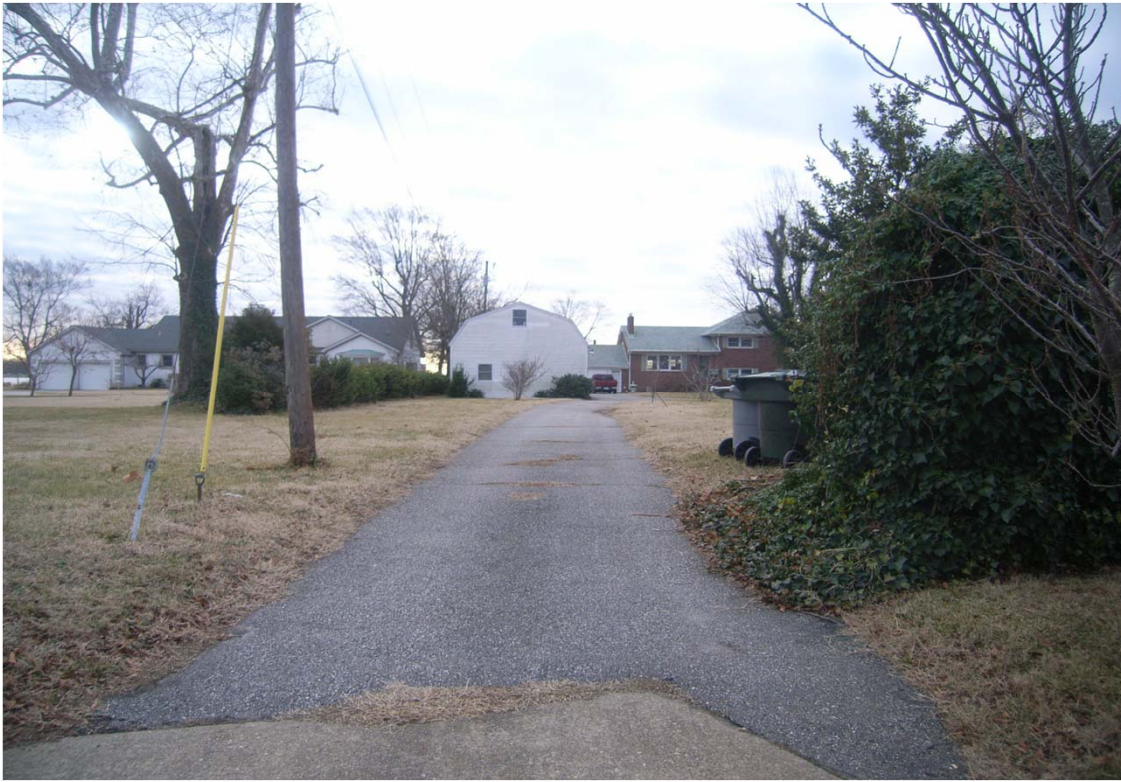
Willard Avenue is not only undersized, but there are questions about its condition, and its routing, which appears to be situated under at least one structure, and it does not appear to be located in a drainage easement, which could inhibit the city's ability to maintain it or replace it in its current location.

**Driveway at 321 S. Willard Avenue-General Route of Outfall #2**

- 4) **Replace the undersized storm drain outfall from S Willard Avenue, out to Mill Creek.** Ideally, the new pipeline should be rerouted along the vacant lot (Peng property) within a 15' wide drainage easement (**which would need to be acquired**). Note: there is an existing 10' drainage and utility easement along the rear of the Mill Creek Terrace subdivision lots but this is encumbered with fences, trees, sheds and other features which make it more difficult to use as a pipeline corridor. The new pipeline should be a 48" diameter (or equivalent non-circular pipe to handle the run-off from a 10 year frequency storm.

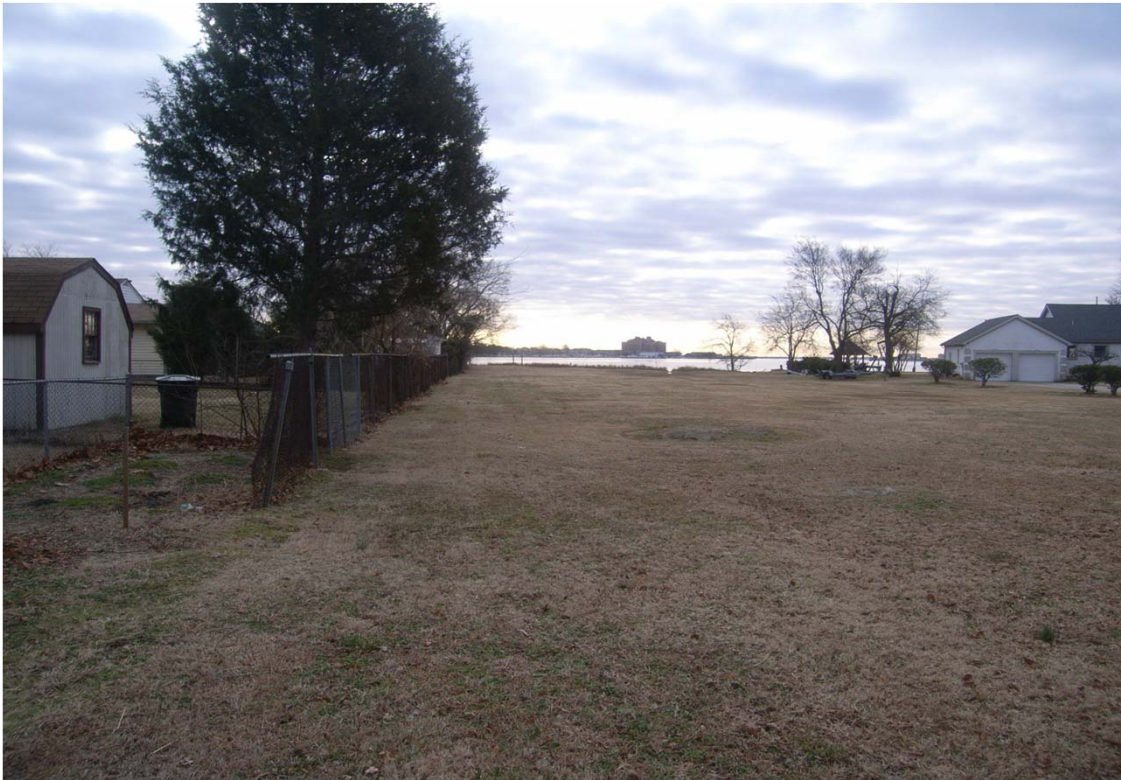
**Vacant Lot at 313 S. Willard Avenue Alongside Mill Creek Terrace Subdivision(Possible New Outfall Route)**

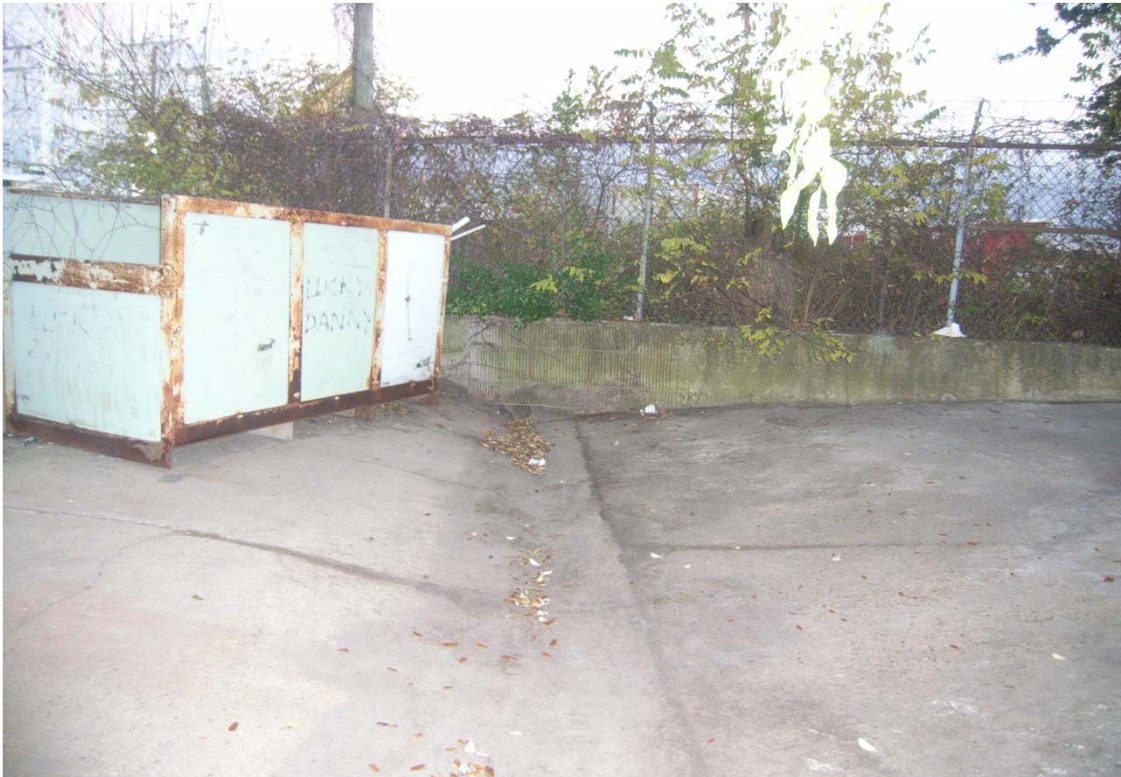
Also, on the Wanchese property, the existing small diameter pipe that serves as an outlet through the existing low wall would need to be replaced with a larger diameter (approximately 15” diameter) pipe (with a backflow preventer), to increase the flow rate of water draining off the property into Mill Creek. Currently, residents in the Mill Creek Terrace neighborhood have observed how slowly the flood waters recede from the Wanchese property, which is due in part to a “choke point” created by this small diameter outfall pipe.

**Wanchese Fish Co. Looking Down Paved Ditch. Note Low Retaining Wall and Drain Pipe (Mill Creek Behind Wall)**

**Also, the small diameter pipeline draining the Wanchese parking lot should be replaced with a 15” diameter pipeline, including a check valve to stop tidal backflow. Because this drainage outfall is on private property, and because it does not drain a public street, (except when the Mill Creek Terrace cul de sac overflows on the Wanchese property), replacement of this pipeline with public funds may be more difficult to justify.**
